## Ice Action on Riprap Small-Scale Tests

Devinder S. Sodhi, Sharon L. Borland and Jesse M. Stanley September 1996

# CRREL Report 96-12

Cold Regions Research &  
Engineering Laboratory

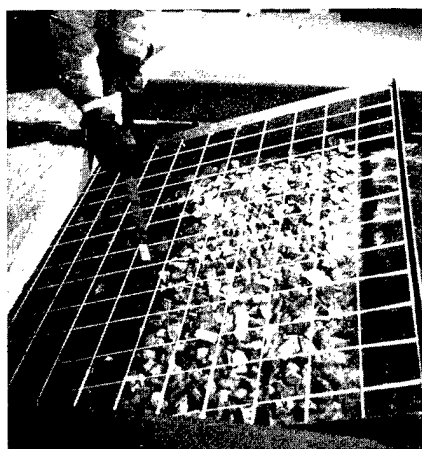
*Figure 13. Measurement of the distance of the riprap surface from the strings at each grid point.*

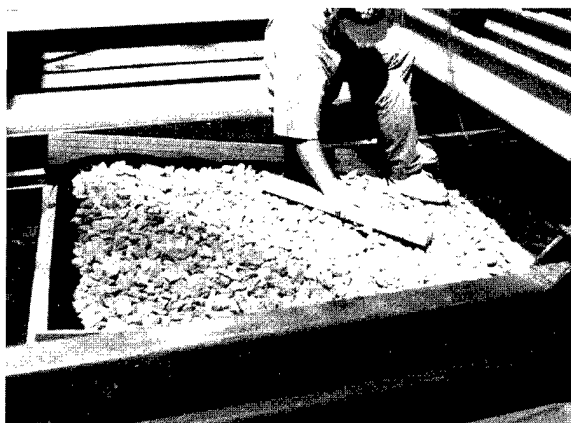
Figure 14. Leveling rocks of model riprap in final preparation prior to each test.

Before each test, we carefully leveled the rocks on the model riprap bank and filled in gaps in the riprap layer where necessary, as shown in Figure 14. The angle of the model bank was adjusted by changing the effective length of the support rods at the front (submerged) end of the model. Prior to freezing an ice sheet, we adjusted the water level in the test basin so that the model was submerged about halfway. We measured the water level relative to the model bank for each test and profiled the rocks using a grid technique explained above. We took photographs of the rocks directly above the model from a fixed vantage point before, dur-

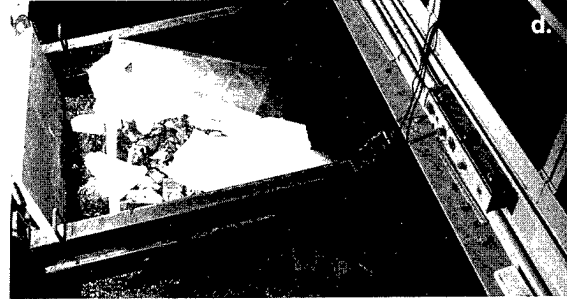
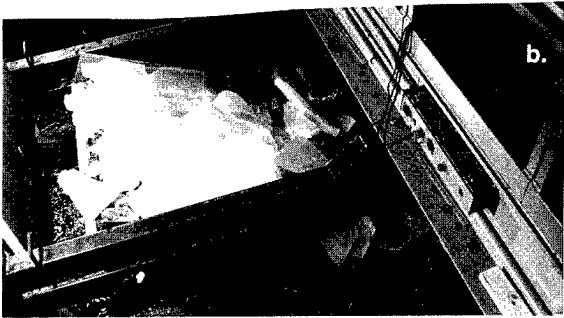
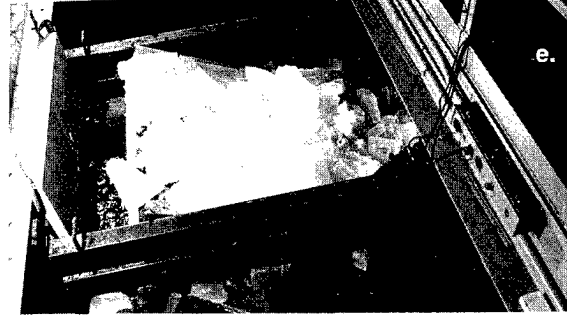
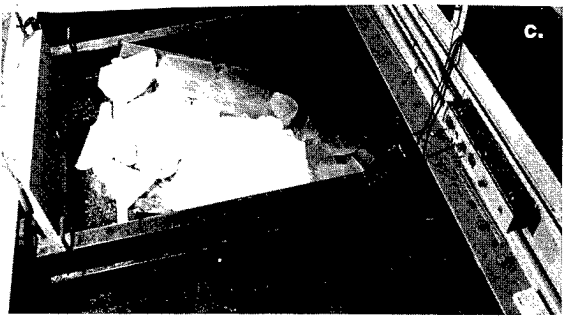
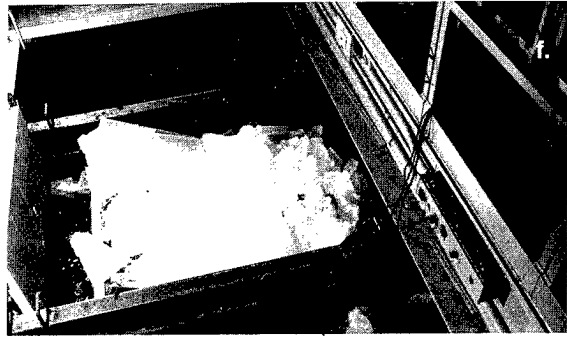
Figure 20. Sequence of ride-up and pileup events for test 20, in which the ice thickness was 53 mm (2.1 in.), and the bank slope was  $27^\circ$  (1V:2H).

mm (2.1 in.). As shown in Figure 20a, the ice sheet broke into roughly rectangular-shaped pieces approximately 25 cm (10 in.) square as soon as the ice sheet contacted the bank above the waterline. Figure 20b shows the broken-up ice sheet going over the top edge of the bank and starting to pile up on one side of the riprap bank. Figure 20c shows the ice sheet riding up and over the top edge of the bank on one side of the model, and beginning to pile up on the other side. As more of the ice sheet continued to shove onto the bank, the ice pieces stacked up on the previously deposited ice

pieces (Fig. 20d). At this stage, no ice was being pushed off at the top edge of the bank because all the ice pieces piled up high, creating a steep incline for the incoming ice sheet. Figure 20e and f show that the ice sheet piled up and crushed into the ice pile. In these last two views, it is possible to see rocks being brought to the surface of the ice pile by the ice sheet. We observed the rocks being transported from the bed to the surface of the ice pile during most of the tests in which the ice piled up on the bank.

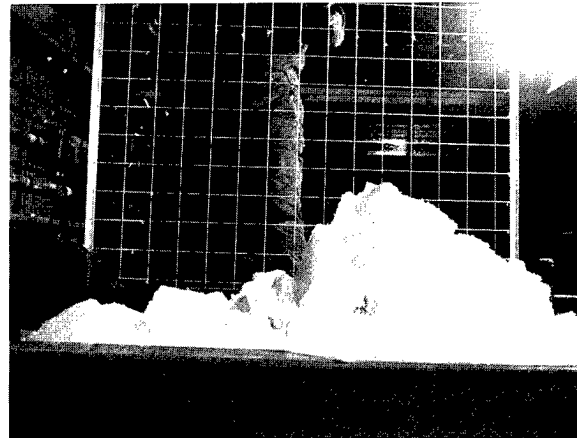
Figure 24. Ice pileup after test 4.

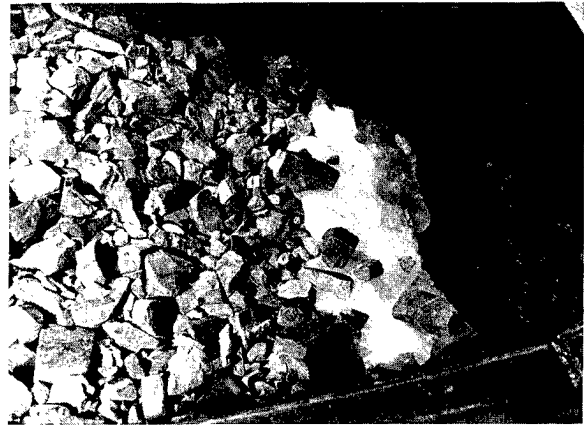
Figure 28. Rocks found on top of the ice pile during melting of ice after test 20.

that some of the rock material was removed from the bed and deposited on top of the ice pile. In some tests, the rocks were tossed from the bed and over the top edge of the bank. Figure 19 shows the rocks in the ice pile towards the end of the test 20. After

this particular test, we allowed the ice to melt on top of the damaged riprap and observed that the model bank was barren of rock under the last bit of ice, as shown in Figure 28. Later, when the ice melted away completely, the rocks on top of the ice were deposited onto the barren patch, though not quite covering it. We observed this “self healing” behavior in many tests after an ice pileup. In the open-water bank protection by riprap, this self healing of riprap also takes place, which makes riprap a popular choice for projects that require low maintenance.

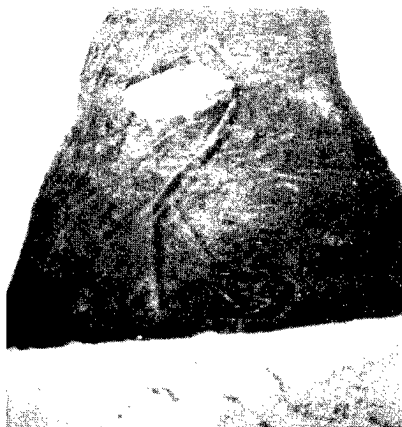
Figure 30. Damage to filter fabric by ice action after test 30.

After an ice run on the smallest stone size (test 8), we observed that the ice sheet had deformed the sand bed as well as the riprap, as shown in Figure 29. After test 30, we observed a far greater amount of ice damage than usually encountered; the ice tore the filter fabric (Fig. 30). These observations indi-

cate that the small-stone riprap was not only inadequate to resist these ice actions, but also made the underlying bank material highly vulnerable to damage by ice.
